iSCAN- II / D91 Latest Versions (July, 2008)

Technical Guidance

VASS ETB (Electronic Throttle Body) System, how to do the basic setting?

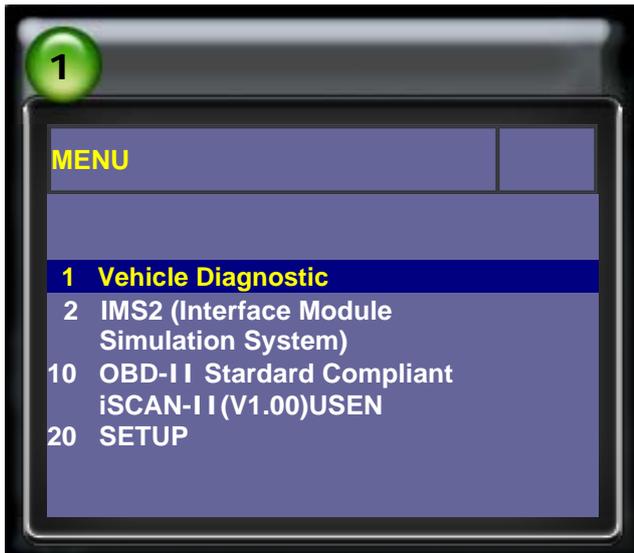
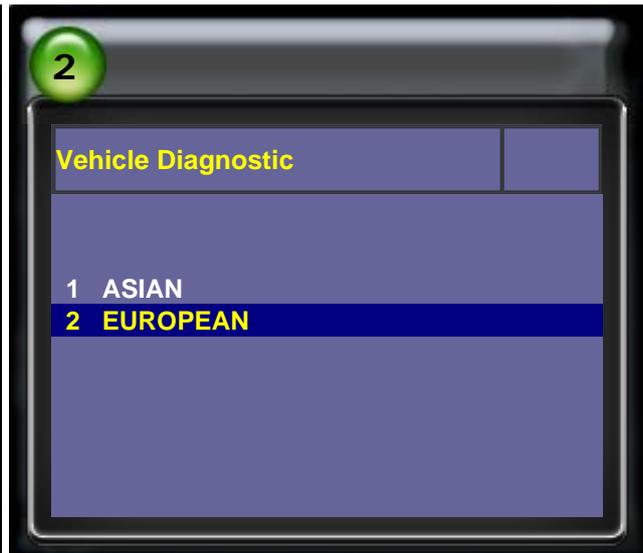
1. Select **Vehicle Diagnostic** → select **EUROPEAN**

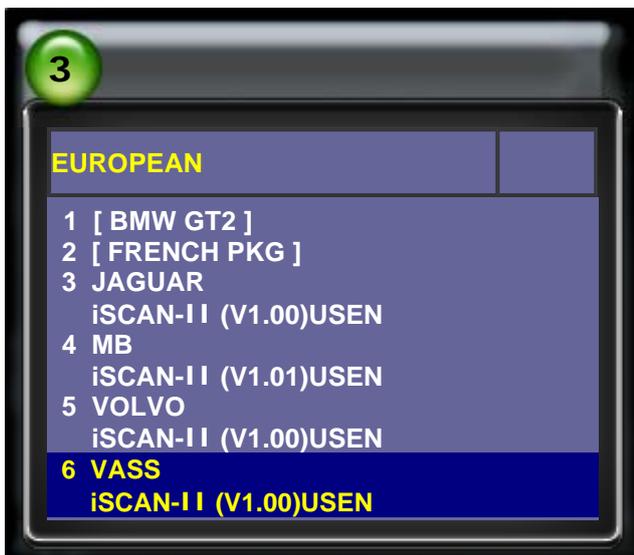
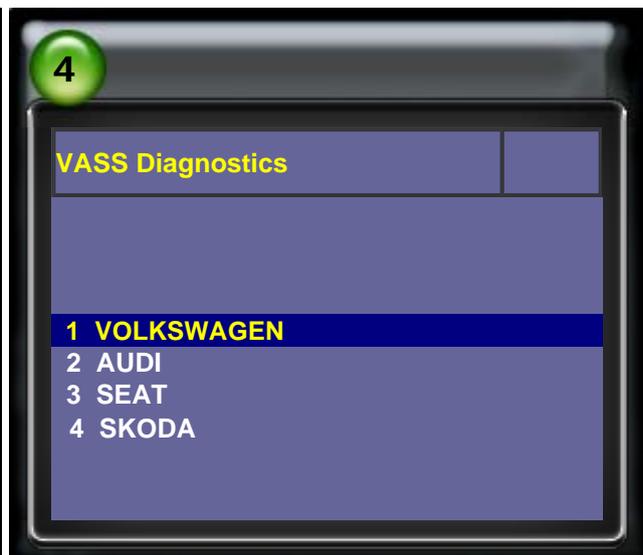
2. Select **VASS** software → select **VOLKSWAGEN**

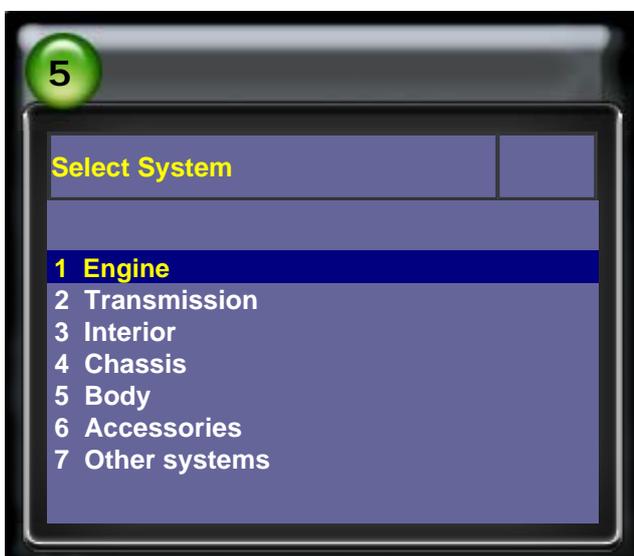
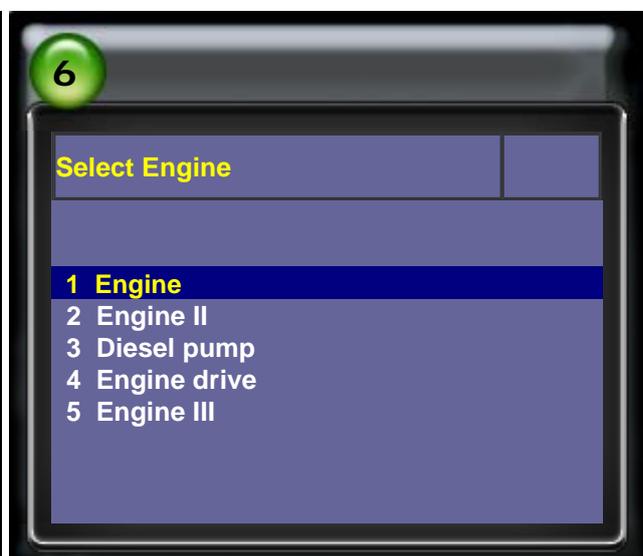
3. Select **Engine** → select Engine type

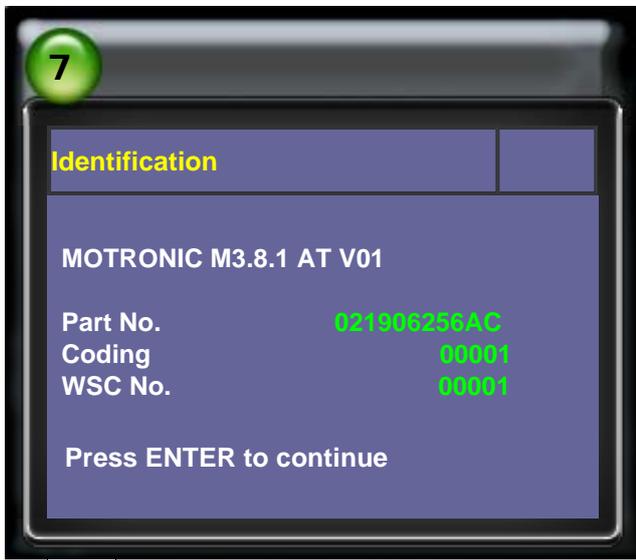
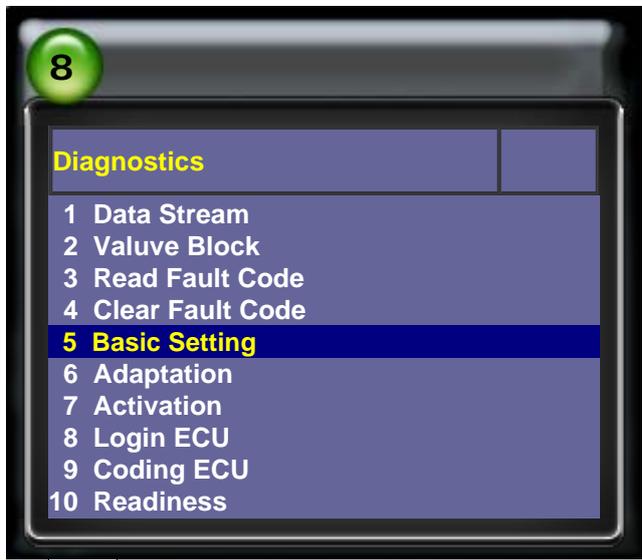
4. Get an identification and press **ENTER** to continue → select **Basic Setting**

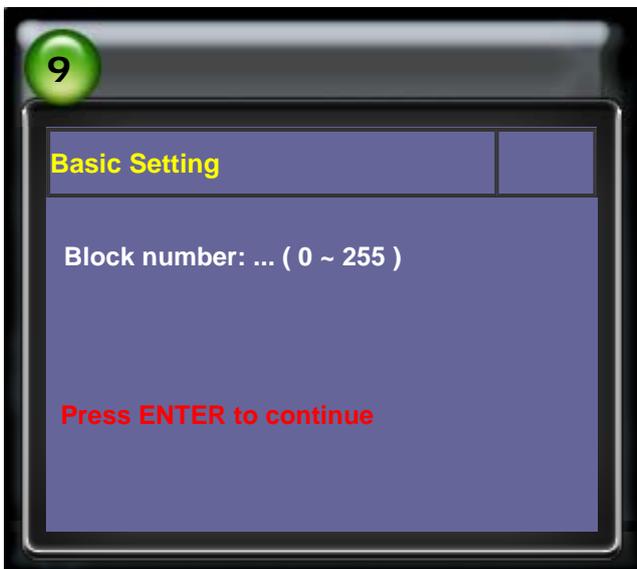
5. According to the engine type, enter the block number.

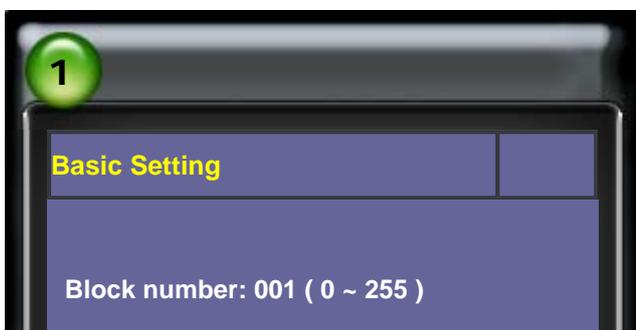
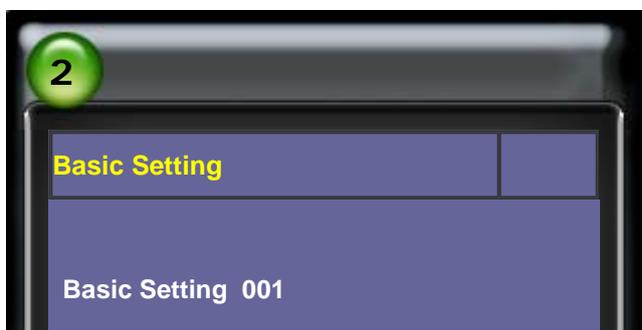
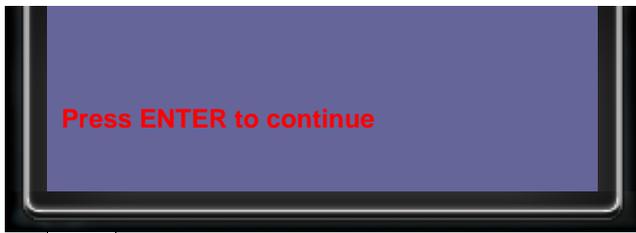
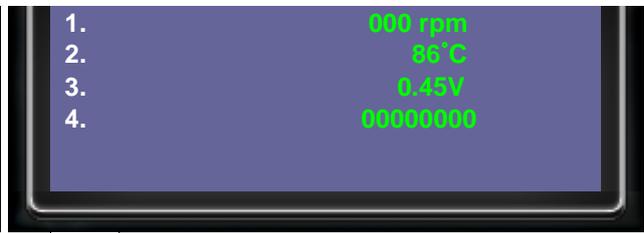
1. Ignition ON, engine not running.
2. Enter **Engine** system, select **Basic Setting**, and enter **001** block number.
3. On 4th item: **00000000** → **00000100** → **00000000**.
4. By the adaption, the engine control unit learns various positions of the throttle valve.
5. Press EXIT and ignition switch OFF for 10 seconds.
 To start the engine again to check if the idle speed is within the standard value.
6. Switch off ignition for at least 50 seconds to store the learning values.

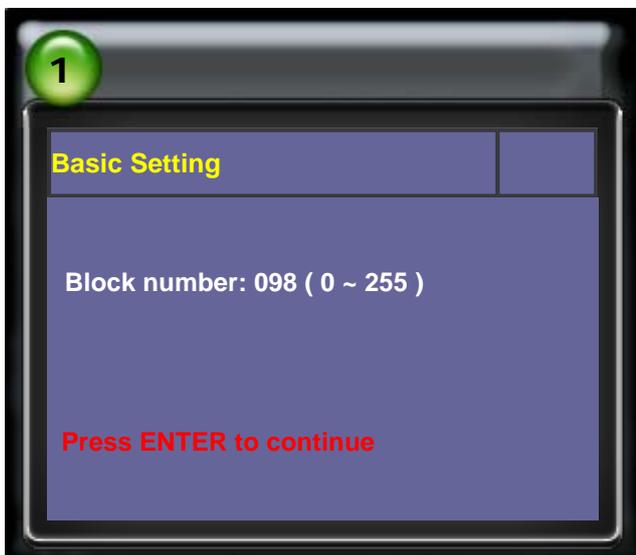
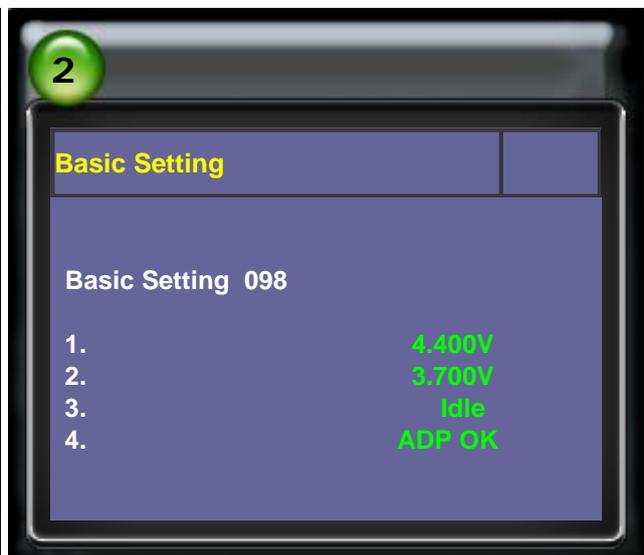
1. Ignition ON, engine not running.
2. Enter **Engine** system, select **Basic Setting**, and enter **098** block number.
3. The 4th item is ADP data, initially it will show **ADP RUN**.
4. By the adaption, the engine control unit learns various positions of the throttle valve.
5. After 6 seconds, the 4th item will show **ADP OK**.
Adaption has been performed successfully.
6. Switch off ignition for at least 50 seconds to store the learning values.

The 4th item is the adaption of ETB (electronic throttle body).

ADP RUN: Adapting

ADP OK: Adaption has been performed successfully.

ERROR: Adaption fails.

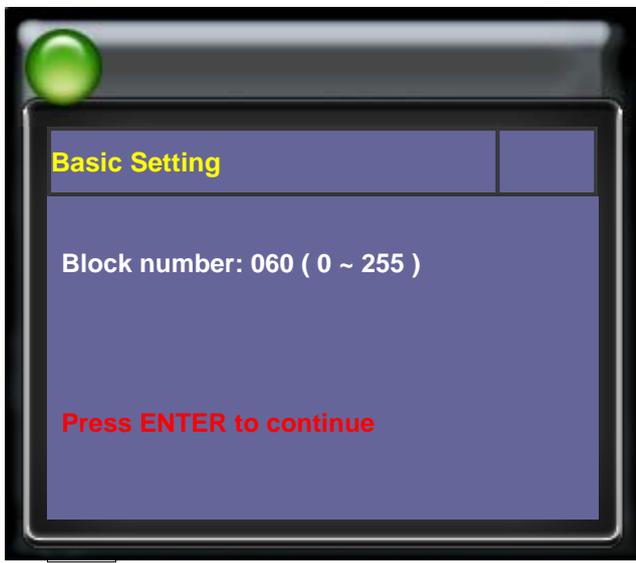
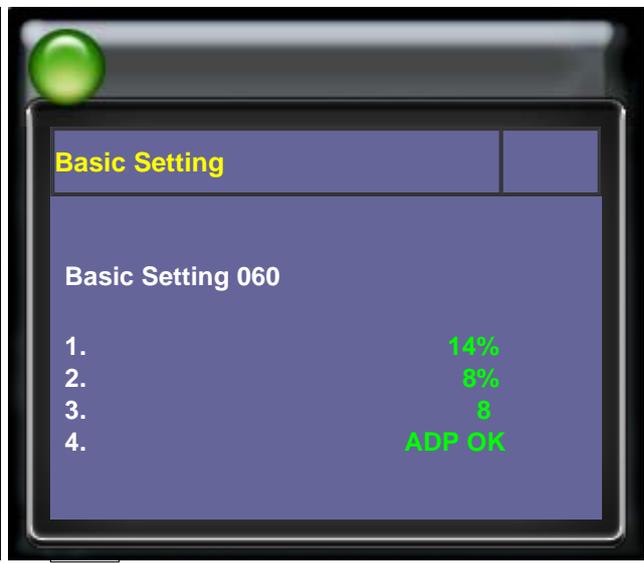
1. Ignition ON, engine not running.
2. Enter **Engine** system, select **Basic Setting**, and enter **060** block number.
3. The 4th item is ADP data, initially it will show **ADP RUN**.
4. By the adaption, the engine control unit learns various positions of the throttle valve.
5. After 6 seconds, the 4th item will show **ADP OK**.
Adaption has been performed successfully.
6. Switch off ignition for at least 50 seconds to store the learning values.

The 4th item is the adaption of ETB (electronic throttle body).

ADP RUN: Adapting

ERROR: Adaption fails
